Manhole Inspection Summary

Manhole # S27C__029MH

Location Address: **725 CHERRY BLOSSOM WAY** Cross Street: **MULBERRY ST**

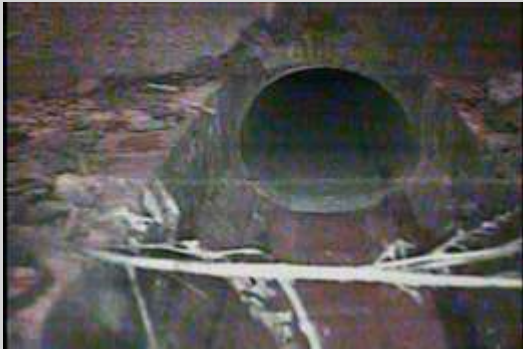
12 O'Clock Outflow

8 in. Circular Gravity Sewer
Pipe Out @ 12 O'Clock

Pipe Height: **8.4** (in.) Rod and Bar (Angled)
Pipe Material: **PVC** ☐ Pipe Lined
Invert Depth: **11.12** (ft.) Flow Characteristics: **Slow**
Deposits: ☒ None ☐ Mud ☐ Sludge ☐ Debris ☐ Grease
Silt Depth: (in.) Deposits Extent:
Infiltration: **None** Pipe Seal Cond: **Sound**
